Intel[®] Pentium[®] III Processor Specification Update

Release Date: May 2007

Document Number: 244453-057

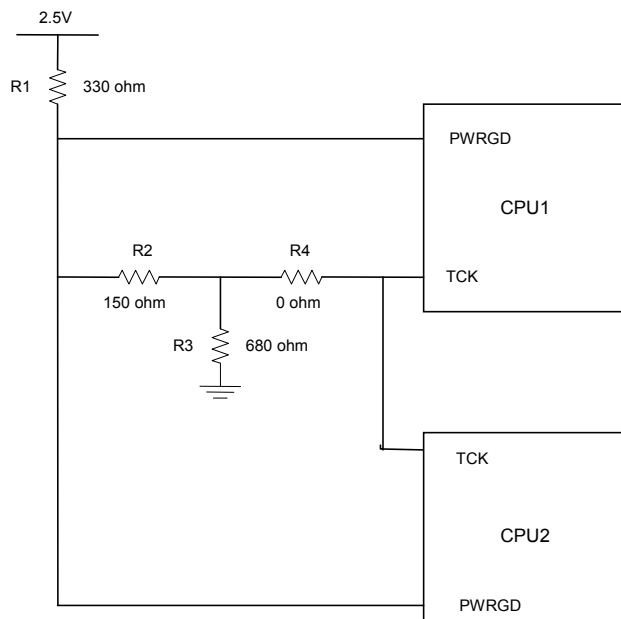
Pentium® III Processor with 512KB L2 Cache Platforms Workaround

Assumes the inputs to the CPU_PWRGD are open collector signals that are Wire-ANDed together

- The example workaround circuit assumes that the PWRGD inputs into the processors are open collector. Tying the PWRGD inputs together in a Wired-AND fashion allows each processor to receive PWRGD at the same time but at the latter of the 2 separate PWRGD assertions. If separation of the PWRGD inputs to each processor is required, extra circuitry will be required.
